RE: Dangerous Waste Compliance Inspection at King County Airport/Boeing Field
RCRA ID# WAD980986848 on February 16, 2005

**Washington Department of Ecology
Hazardous Waste & Toxics Reduction Program
Compliance Report**

Site: King County Airport/Boeing Field

Inspection Date: February 16, 2005

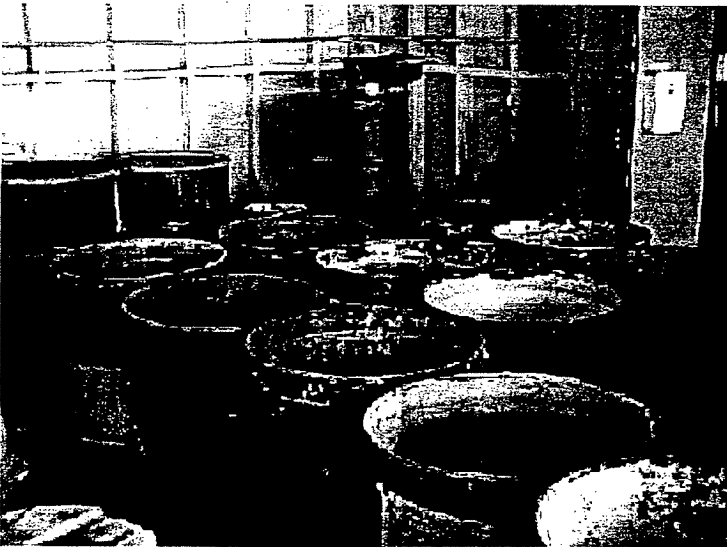
Also in the bull pen area, a 55-gallon drum was being used to collect used oil. The drum sat on a secondary containment pallet. The drum was labeled “Waste Oil” but the label was turned toward the back wall (see photo below – used oil drum is the black drum at the rear with the funnel in the top). Mr. Salazar said he would find out if it was necessary to have this collection drum at all. We asked Mr. Salazar to label the drum as “Used Oil” if its use was continued. We also noted that some secondary containment had been added around the paint thinner drum by surrounding it with 4” x 4” timbers and lining the area with plastic. We mentioned that the fire department would probably like to see a risk label on the drum and that the thinner was considered a product and not a waste as long as it is in use.

The used oil container in the bull pen was labeled as Waste Oil and the label or marking was turned toward the wall so that it was not visible.

Within 10 calendar days of the receipt of this report, label or clearly mark the used oil container with the words "Used Oil". Send a photograph showing this change to Ecology with your Compliance Certificate (see below) on or before April 29, 2005.
